SAFETY ALERT

Failure of explosion-protected characteristics of a diesel engine system

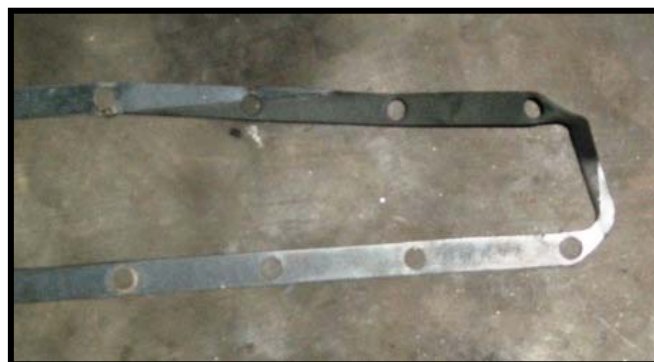
During a mechanical inspection the intake manifold gasket of an explosion-protected diesel engine system was found to be damaged to such an extent that the diesel engine system would not have been in an explosion-protected condition. It appears the diesel engine system may have been operating in this non-explosion-protected condition for about 2000 hours before the inspection.

The failure was detected at the scheduled code 'D' inspection. The intake manifold gasket had been incorrectly installed at the previous code 'D' inspection.

1. Between the mechanical code 'D' inspections (2000 hours) the intake manifold or gasket had not been replaced by the mine.
2. The intake gasket appears to have been dropped while the intake manifold was being installed at the previous code 'D' inspection.
3. The gasket was not broken, however, it was not lined up with the bolt holes.
4. There were some witness marks on the manifold and gasket showing this explosion-protected joint was most likely compromised.
5. The mine carries out visual and soapy water tests every 250 hours engine operating. No defects were identified during these inspections and tests.

The intake gasket of the diesel engine system.

1. Review the installation procedures in relation to explosion-protected joints.
2. Consider support and location of gaskets with studs when assembling components.
3. Verify the integrity of fixed connections following installation of components, particularly joints where negative pressures are found, as soapy water testing may be ineffective.
4. Undertake all activities in accordance with the information and procedures provided by the designer, original equipment manufacturer, or otherwise by a competent person (refer to Clause 137 of the *NSW Occupational Health and Safety Regulation 2001*).
5. Refer to the original equipment manufacturer for guidance regarding the above.
6. Be competent for the task being undertaken with an understanding of the hazards and risk controls.
