# SAFETY ALERT

## Drill rig incident

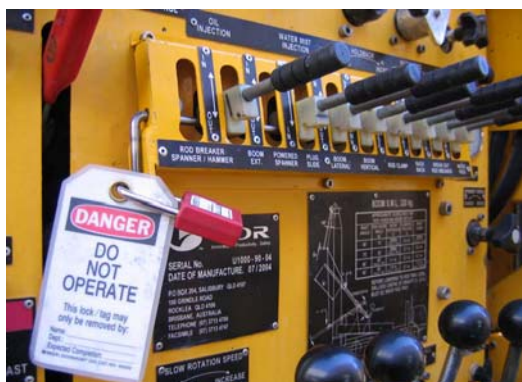
The above photo shows the recommended isolation of a drill rig control panel. It was not in use at the time of the incident outlined in this Safety Alert. However this isolation device allows for selective isolation of individual levers as required.

- Mechanically isolate drill rig controls to enable selective isolation of control levers. (See attached photo for example)
